Finding Mould and Water Damage with an Infrared Camera

Infrared cameras can see temperature differences in surface temperatures. This can be used to "see" irregularities in walls and ceilings arising from the presence of water or other anomalies. Mould needs water to grow so if you can find the water, you can find the mould.

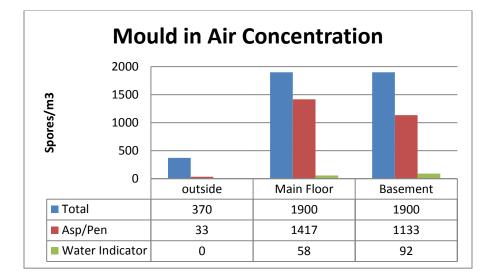
The images above were taken in a home having air quality issues. The first image (A) is what the naked eye sees. No apparent issues with the naked eye. The middle image (B) is what the infrared camera sees. A purple irregularity is clearly seen on the back wall of the shower up by the roof. This is an indication of water intrusion and possible mould growth. Image C shows the wall cavity exposed. Water had compromised the fiberglass insulation and resulted in mould growth in the cavity. Air testing showed elevated presence of aspergillus/penicillium moulds – common problematic moulds when there is a moisture problem in a home.
